**NPDES
INSPECTION REPORT**

**WASTEWATER TREATMENT FACILITY
PARMA, IDAHO**

**INSPECTION DATE: June 6, 2012
REPORT DATE: June 20, 2012**

**Prepared By:
Michael Spomer
Technical Services
Idaho Department of Environmental Quality**

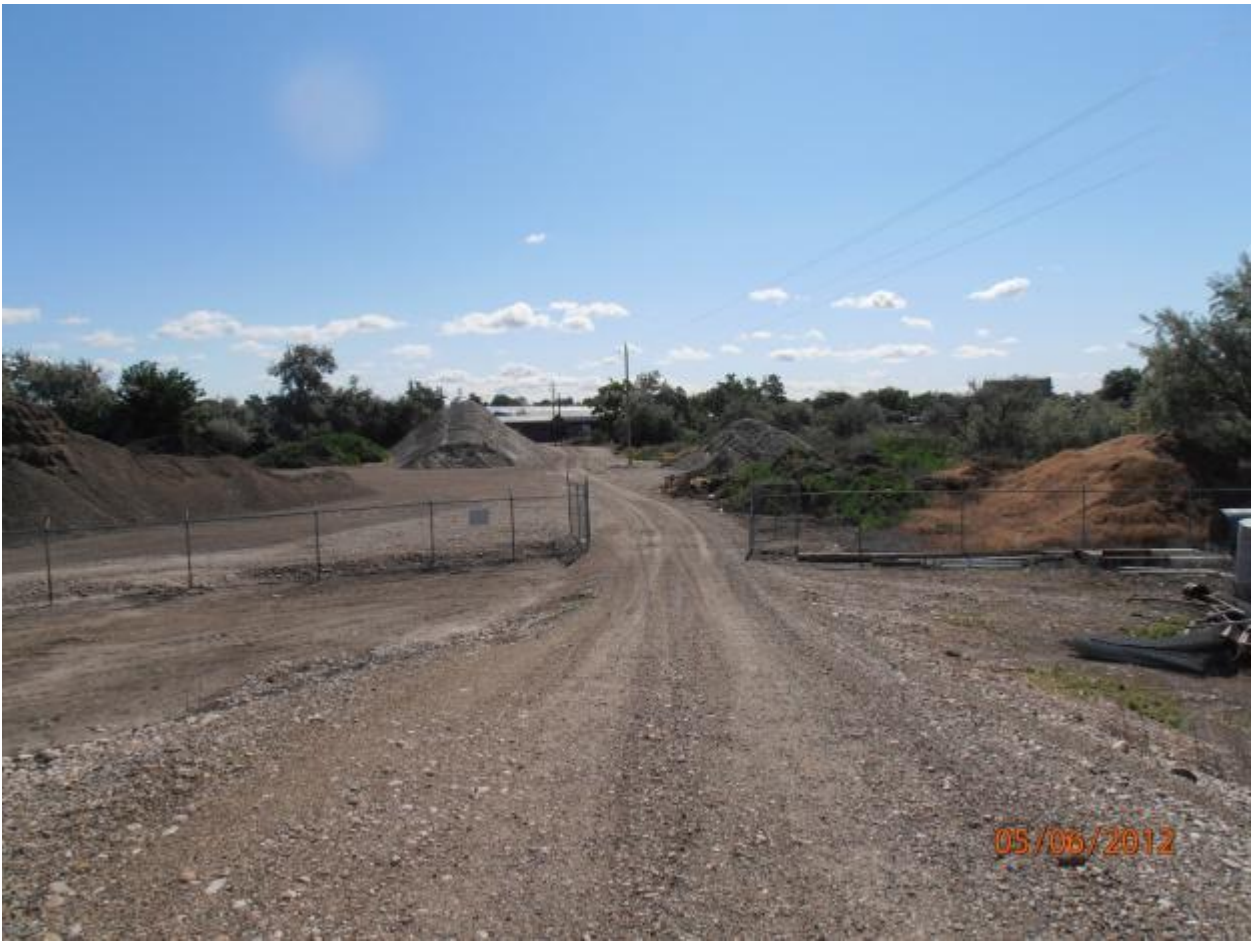
Photograph 1. Looking out the entrance towards the east.

Facing east. Looking out the entrance to the lagoons.

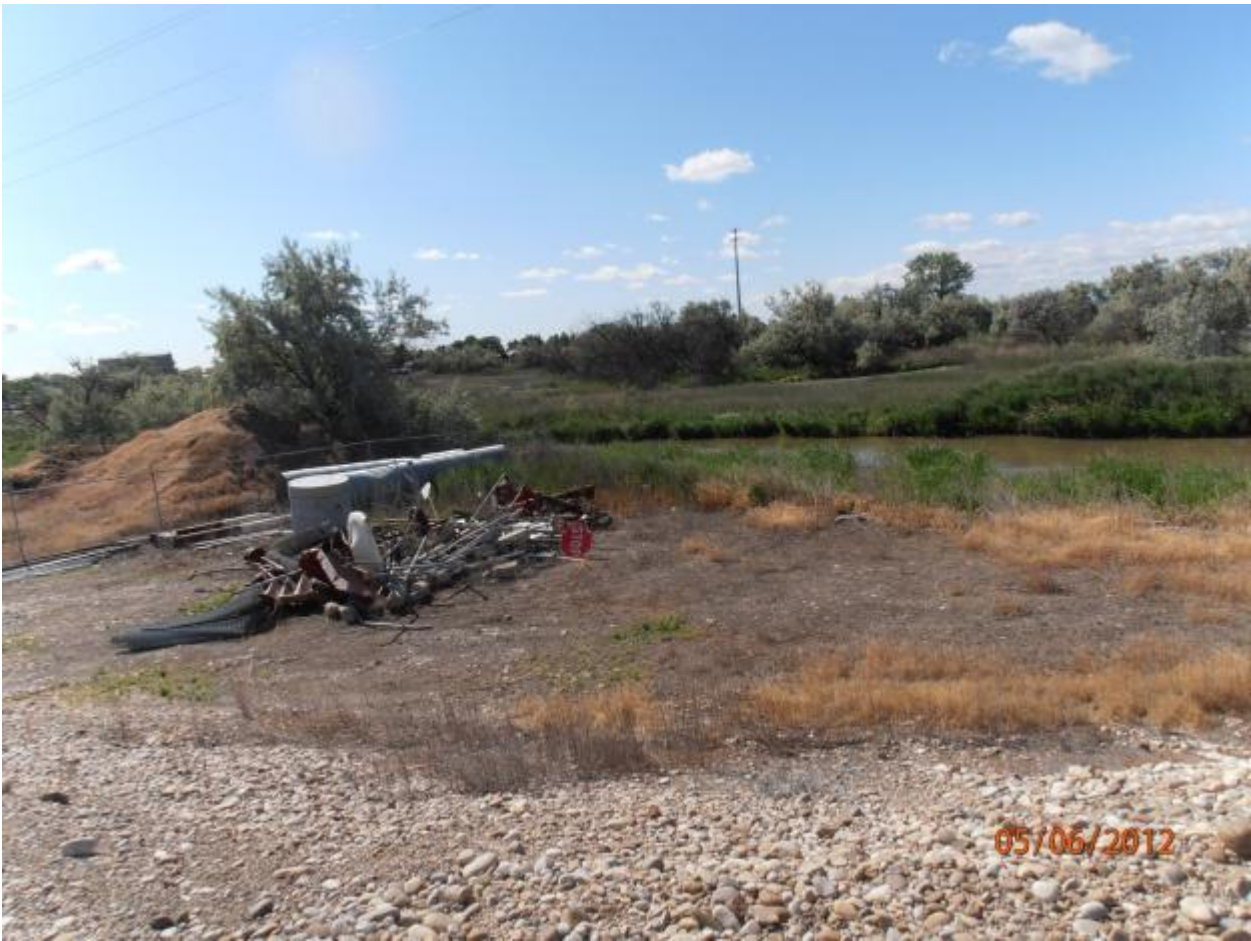
Photograph 2. Sandhollow Creek.

Looking southeast from the lagoon dike towards Sandhollow Creek,
the receiving surface water, at the point it enters the facility.

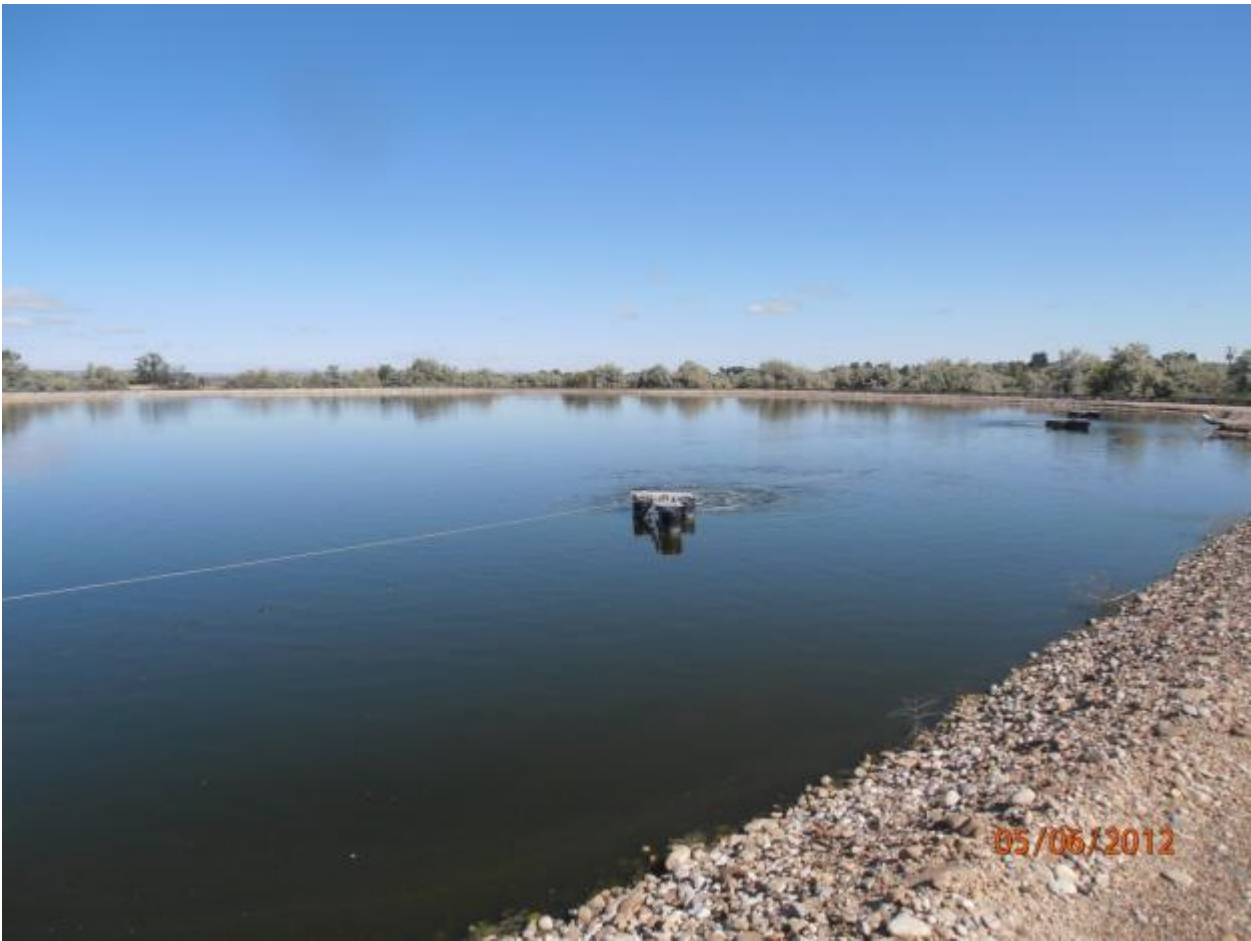
Photograph 4. Aerators in Lagoon #1.

Facing north northwest at an aerator in Lagoon #1.

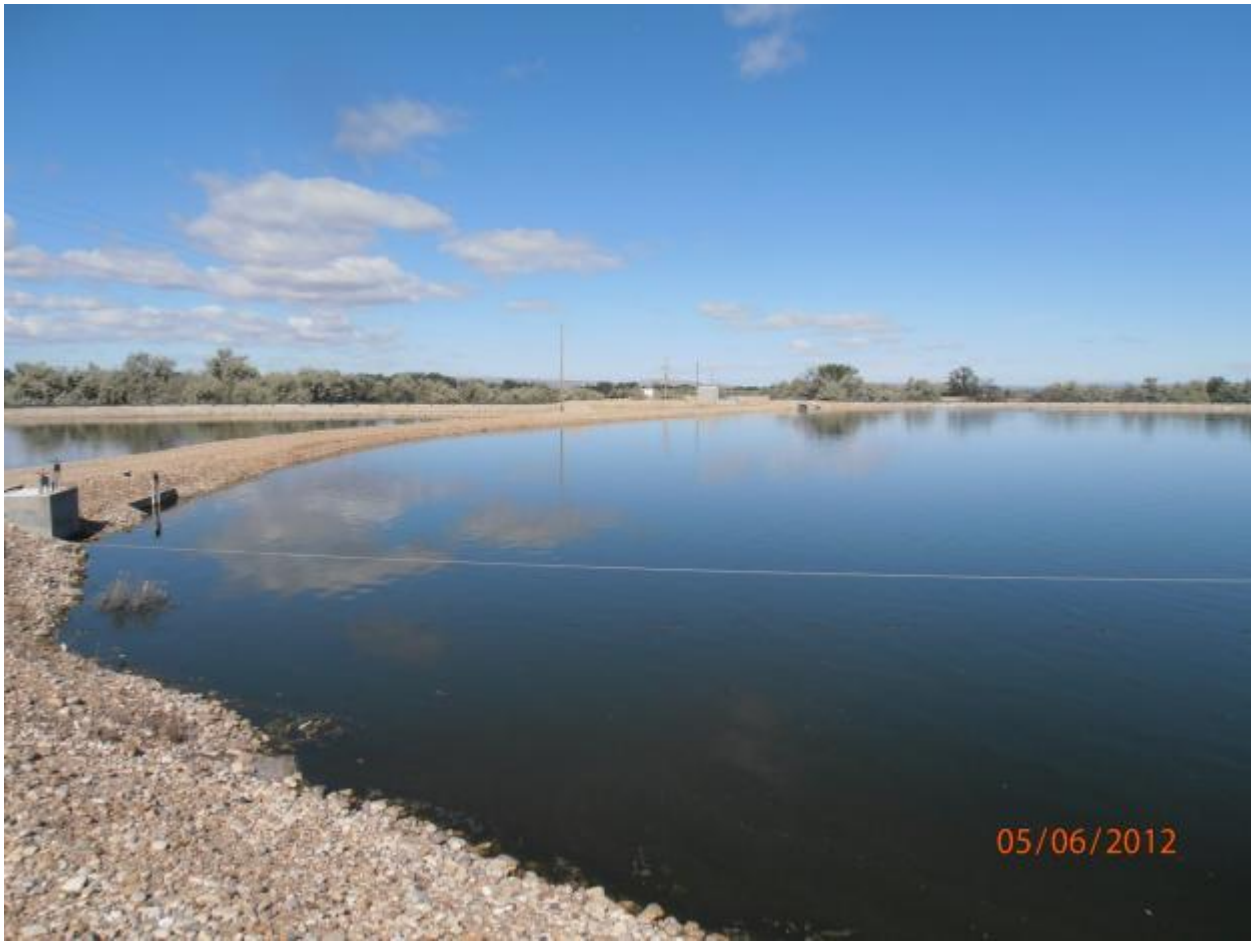
Photograph 5. Lagoon #1 and dike separating Lagoon #2.

Facing west down dike separating Lagoon #1 from Lagoon #2.

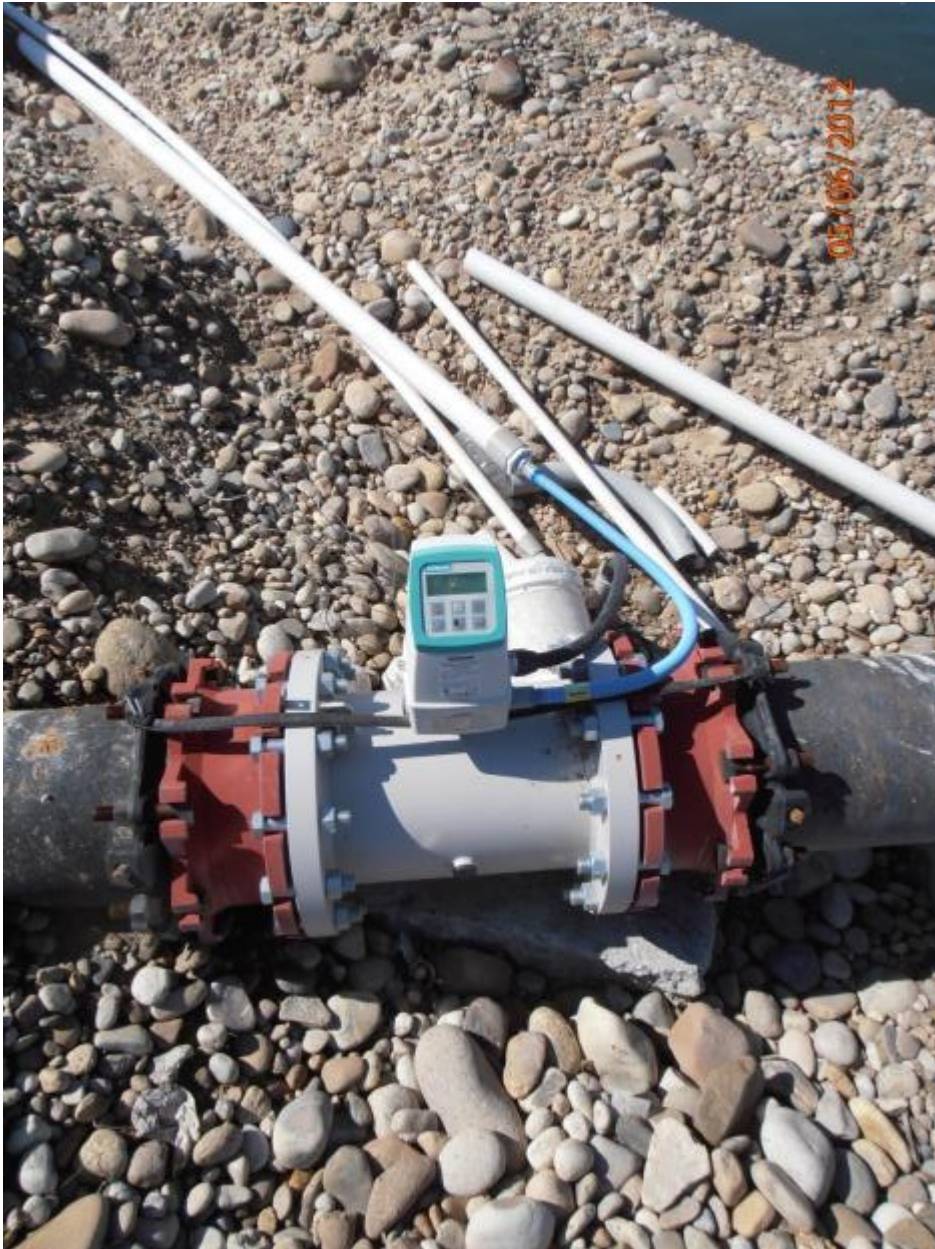
Photograph 7. Influent Flow Meter.

Facing south. Lagoon #1 influent flow meter.

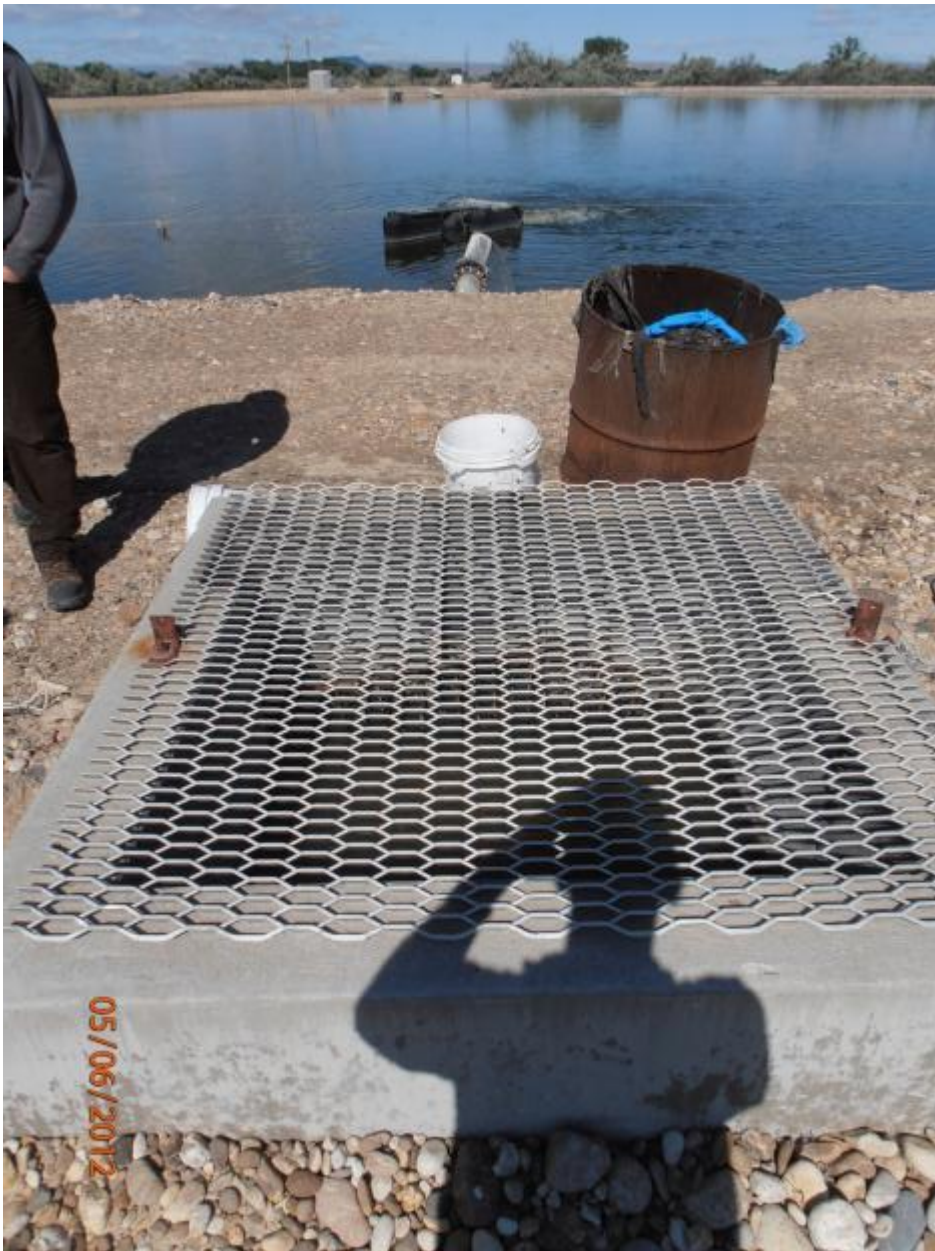
Photograph 8 Influent wet well prior to flow meter.

Facing west. Influent wet well prior to flow meter and discharge to Lagoon #1.

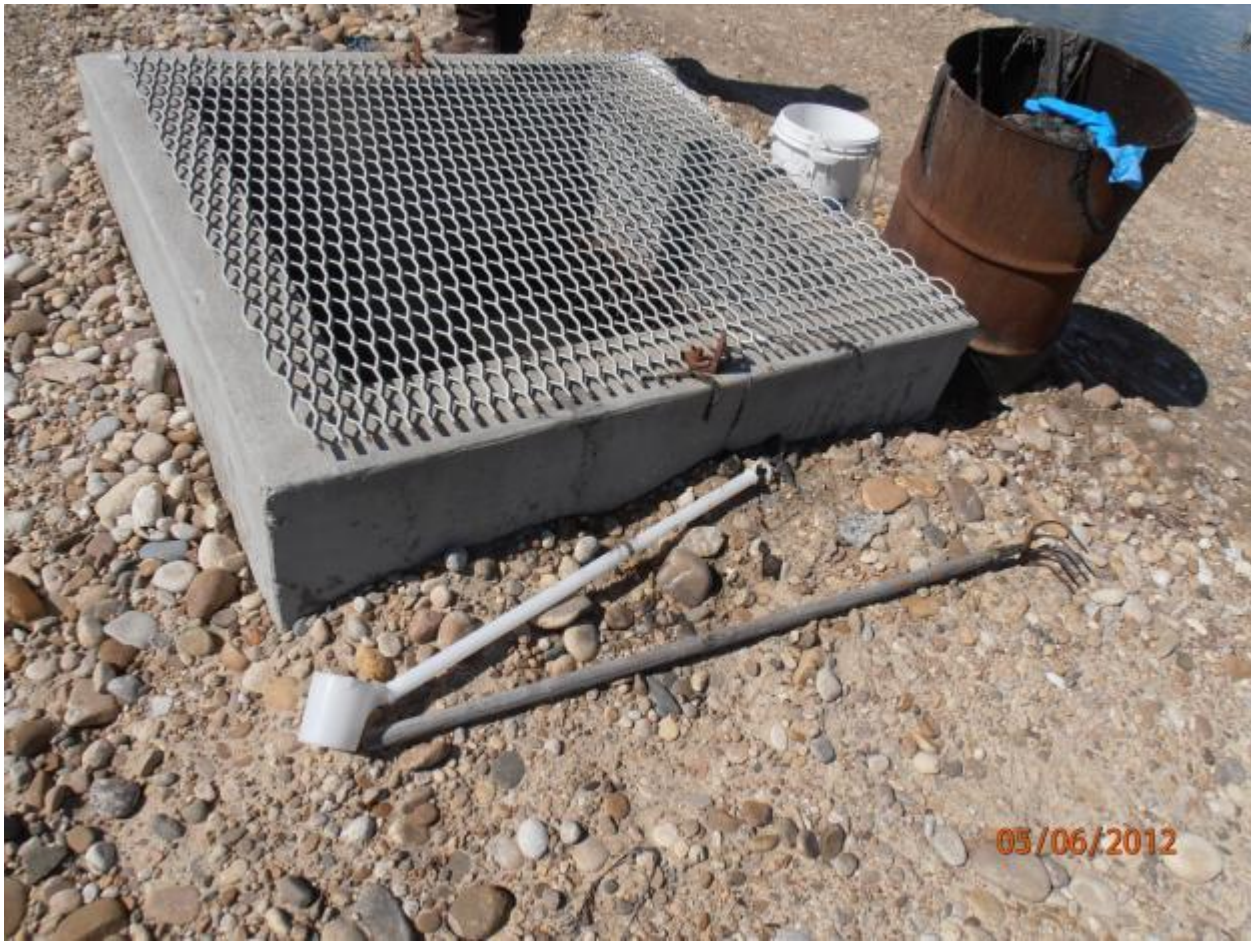
Photograph 9. Wet well, influent sampling point and equipment.

Facing south southwest. Wet well that receives lift station effluent where influent samples are collected.

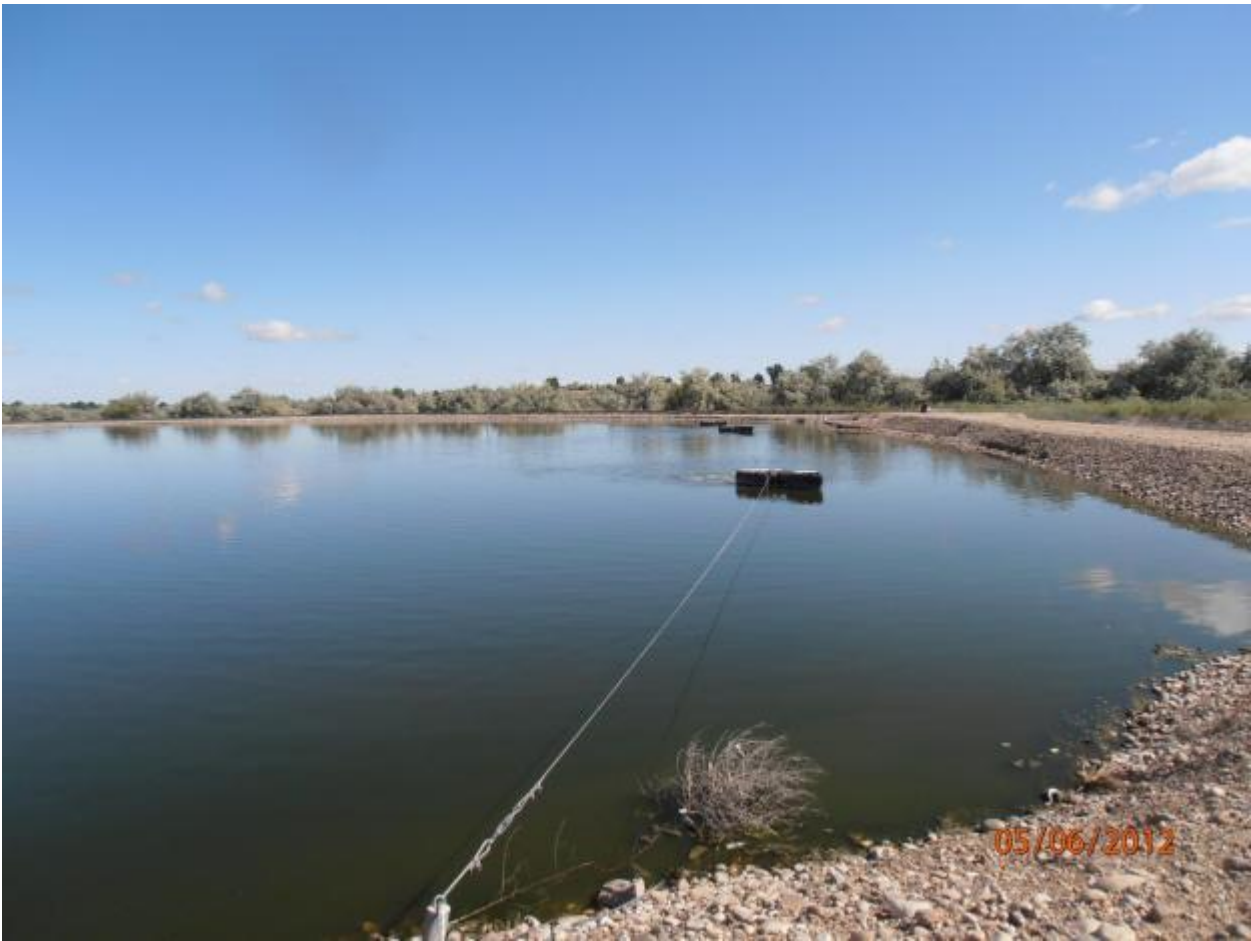
Photograph 10. 3 of Lagoon #1's 5 aerators.

Facing north on dike separating Lagoons #1 and #2 at the eastern string of aerators.

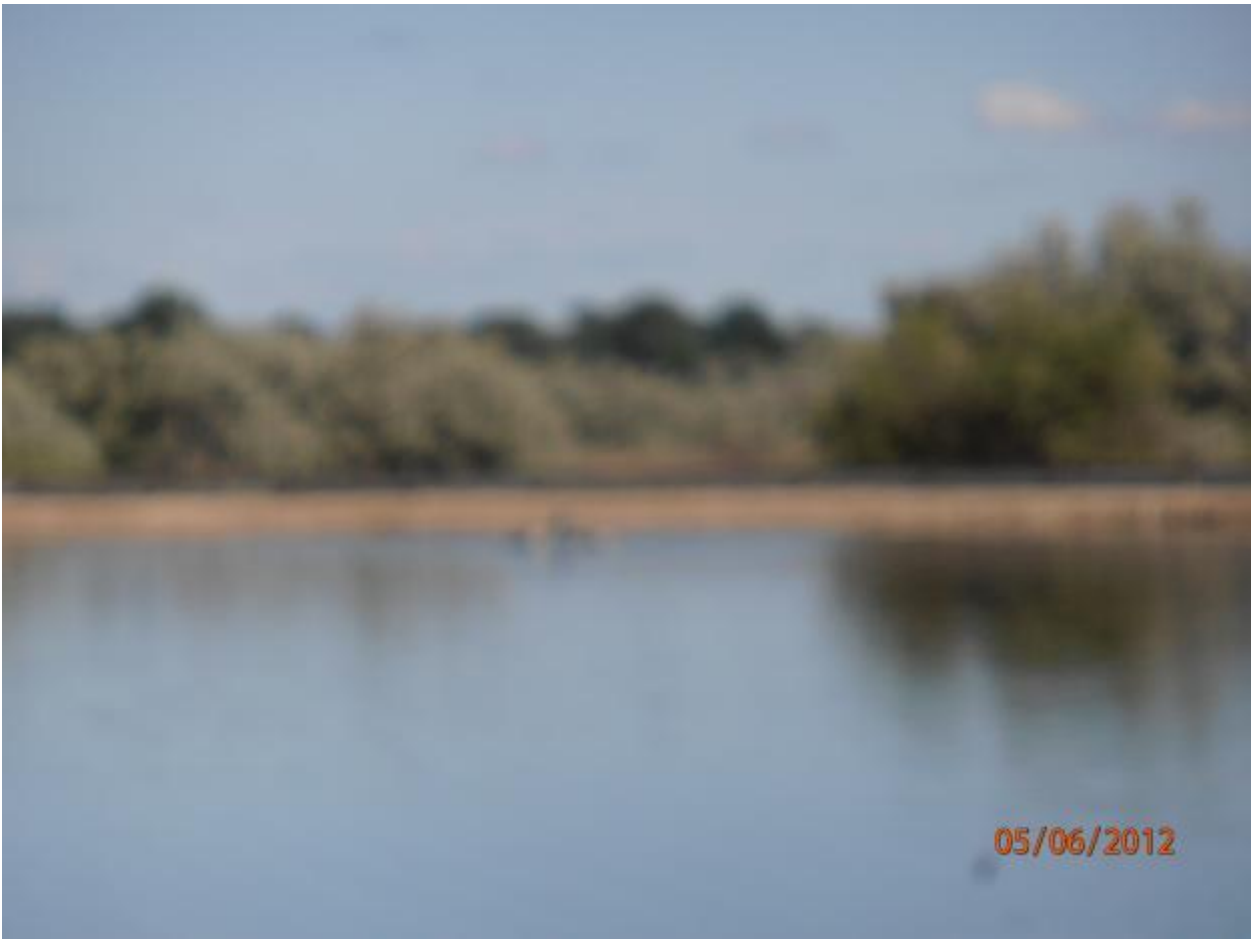
Photograph 11. Telephoto picture of Lagoon #1's aerator.

Facing northwest across Lagoon #1 at an aerator on the far side.

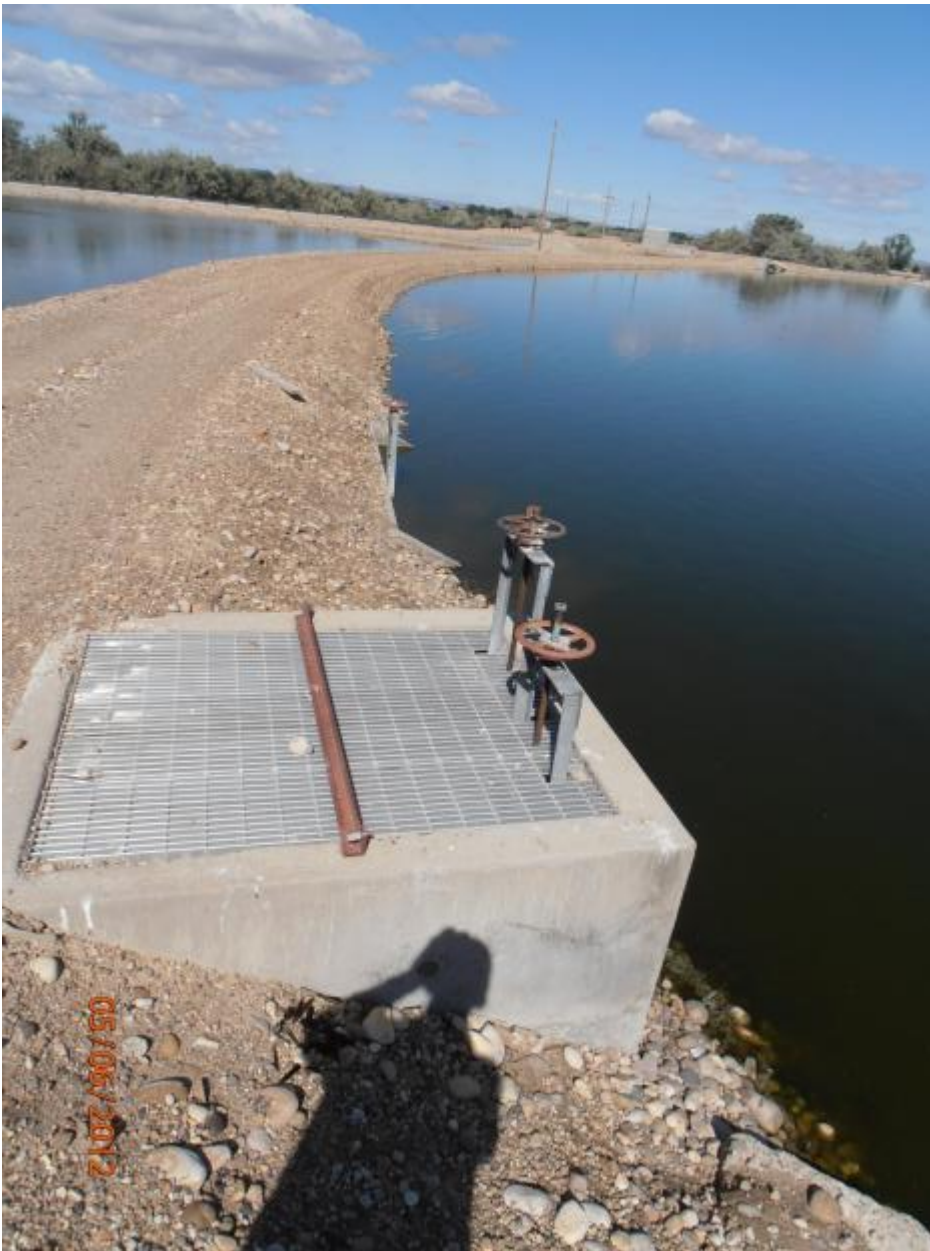
Photograph 12. Valvebox controlling flow from Lagoon #1 to Lagoon #2.

Facing west near entrance to lagoons. Valve box that controls flows to Lagoon #2.

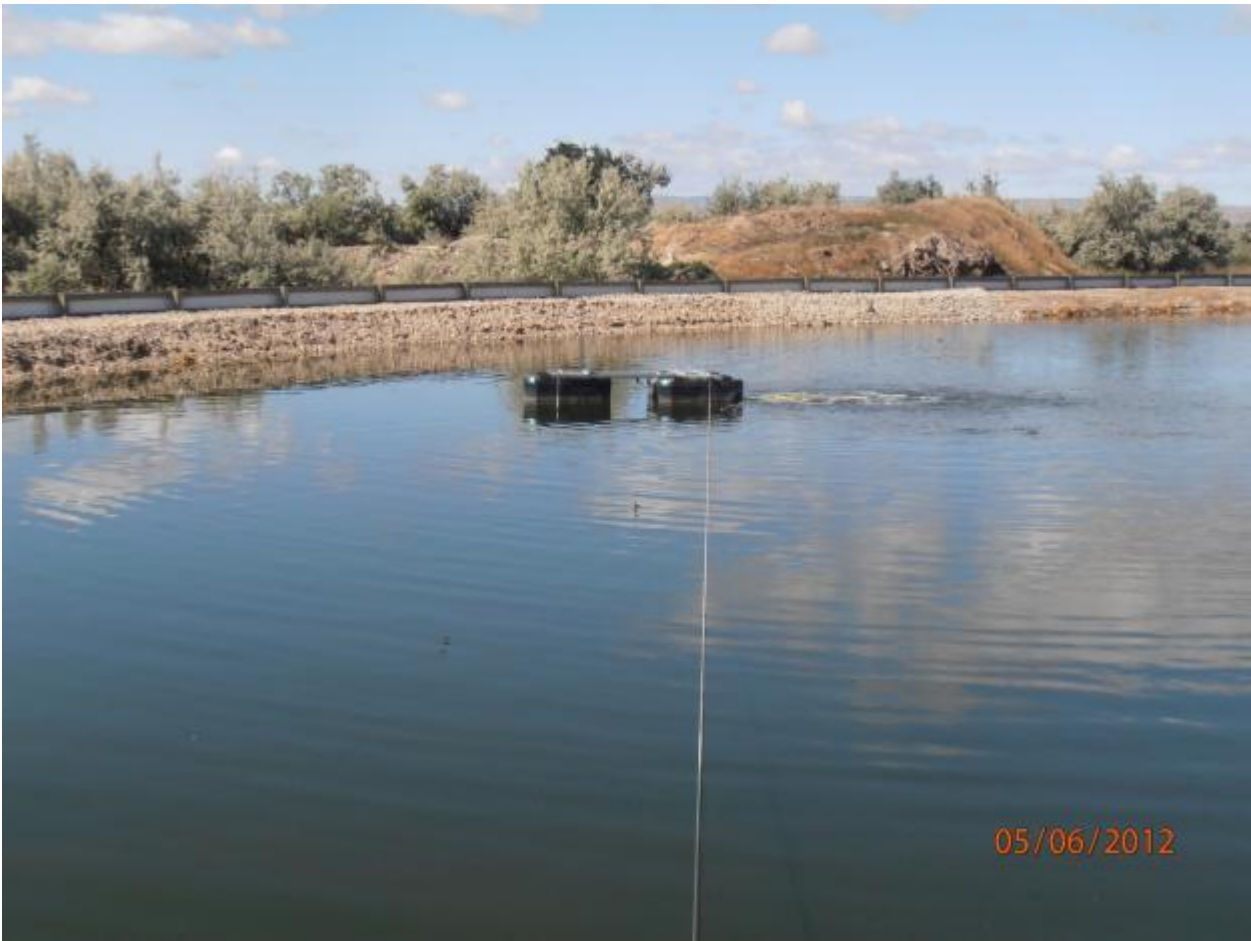
Photograph 13. Aerator in Lagoon #2.

Facing southwest towards Lagoon #2's aerator, and lagoon's southern dike.
Sandhollow Creek is immediately on the far side of this dike.

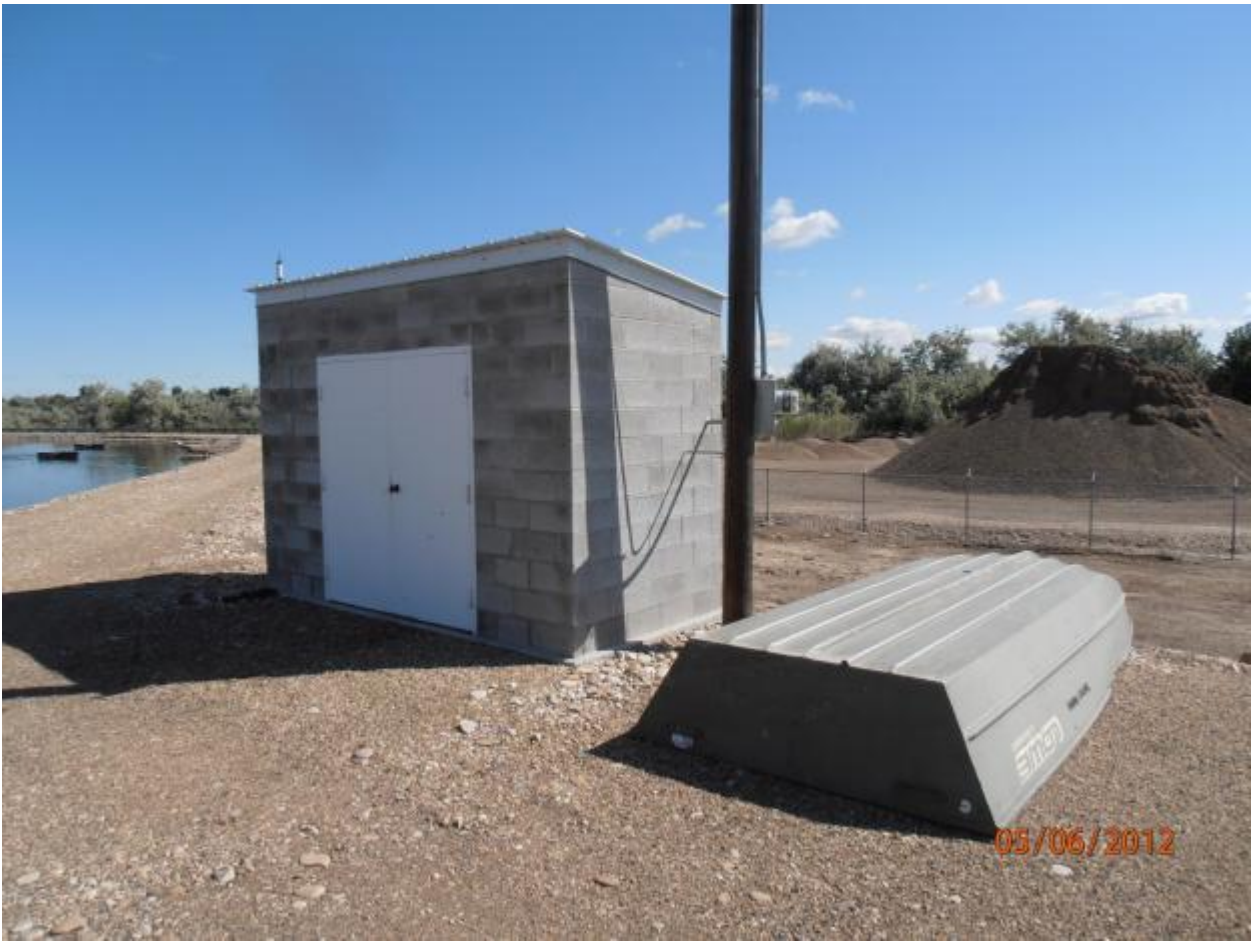
Photograph 14. Aerator motor control house and flat bottomed boat.

Facing north at lagoon entrance at the Motor Control Building and service boat.

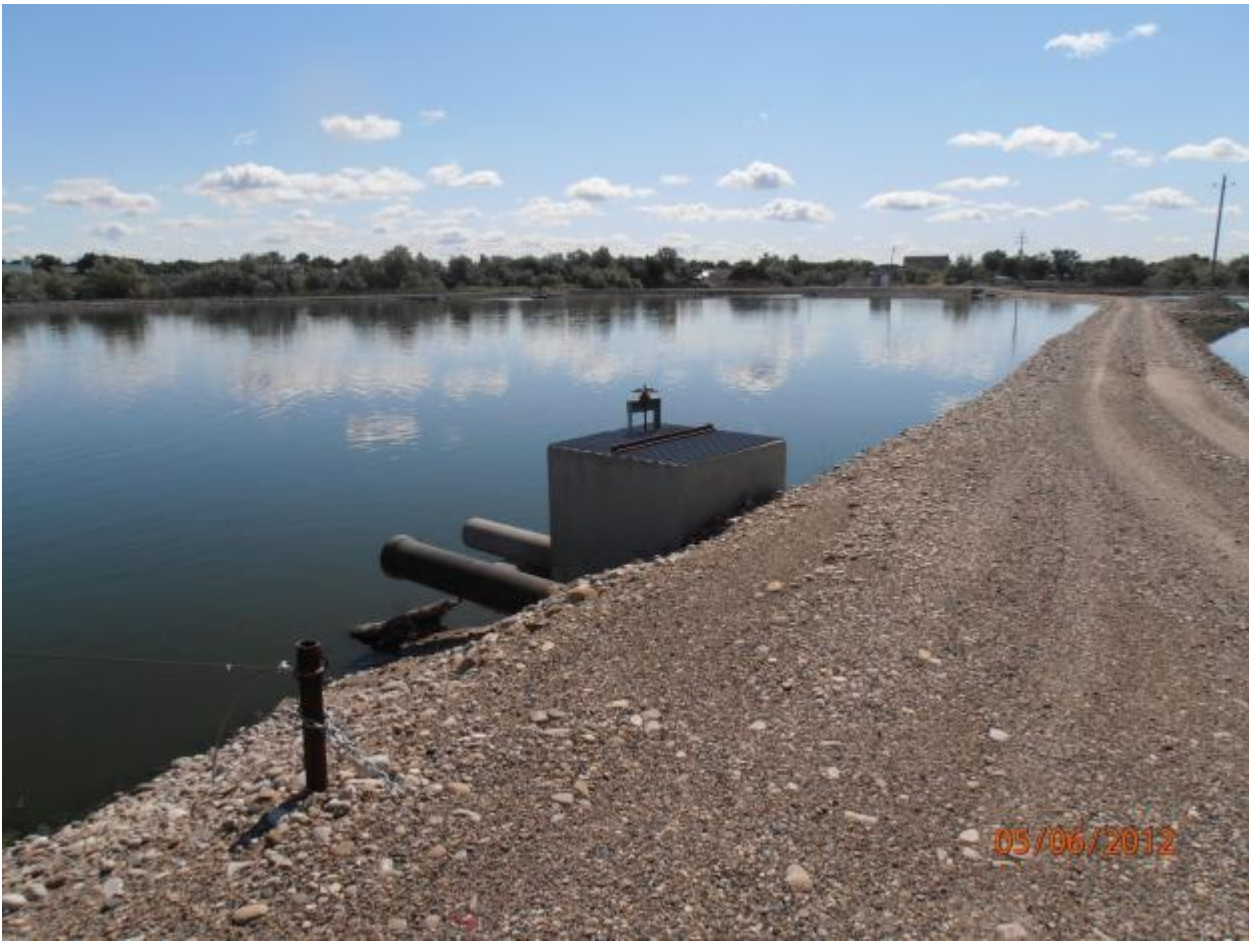
Photograph 15. Lagoon #3 discharge point back to Lagoon #2.

Facing south southeast with Lagoon #1 in background. Lagoon #3 is immediately to the right. This is the discharge into Lagoon #1 from Lagoon #3, used when effluent quality is not good enough to send to sand filters, disinfection, and discharge.

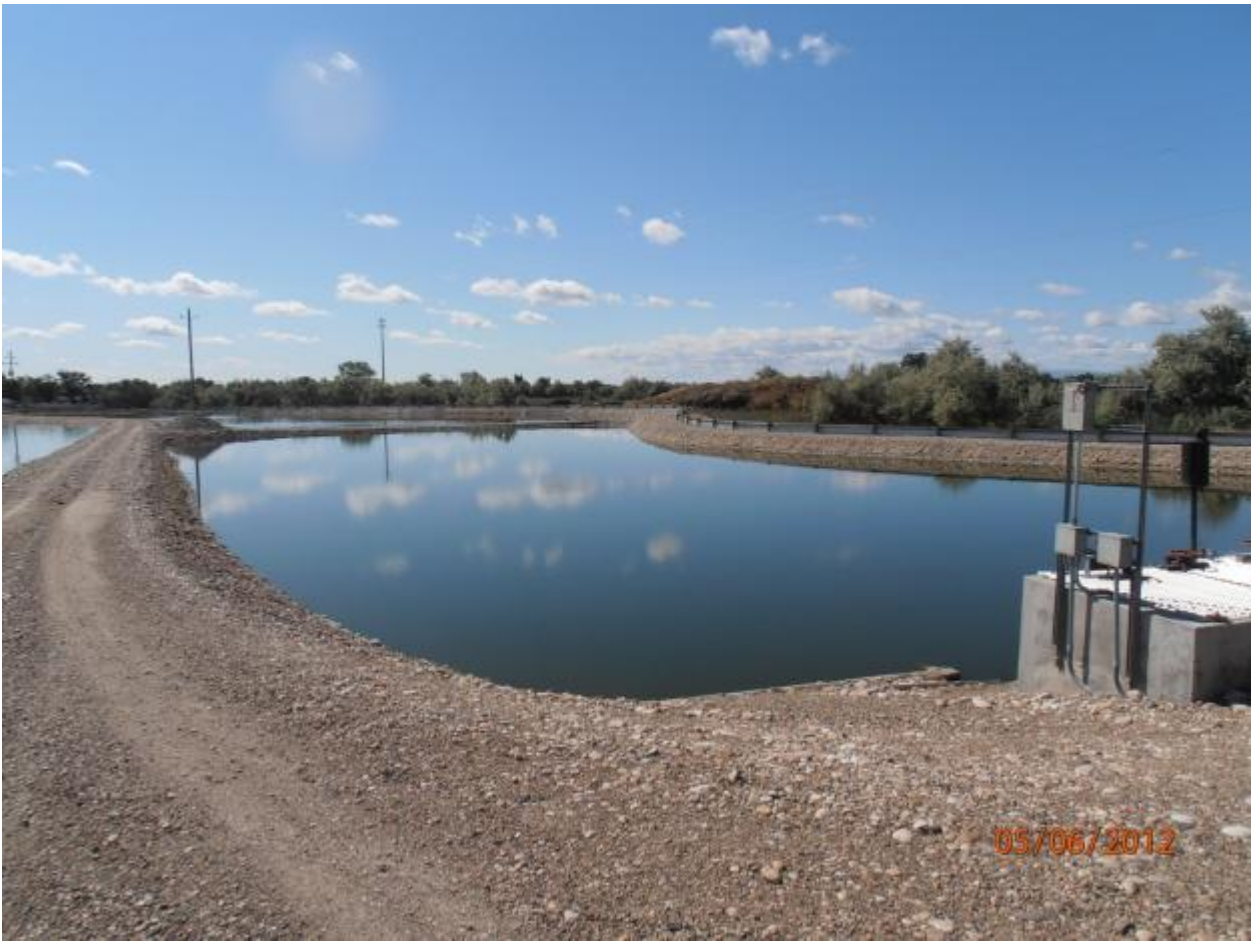
Photograph 17. Lagoon #3, showing dike separating Lagoon #2 in the background.

Facing southeast. Lagoon #3 and its re-route control structure on the right-hand side of photo.

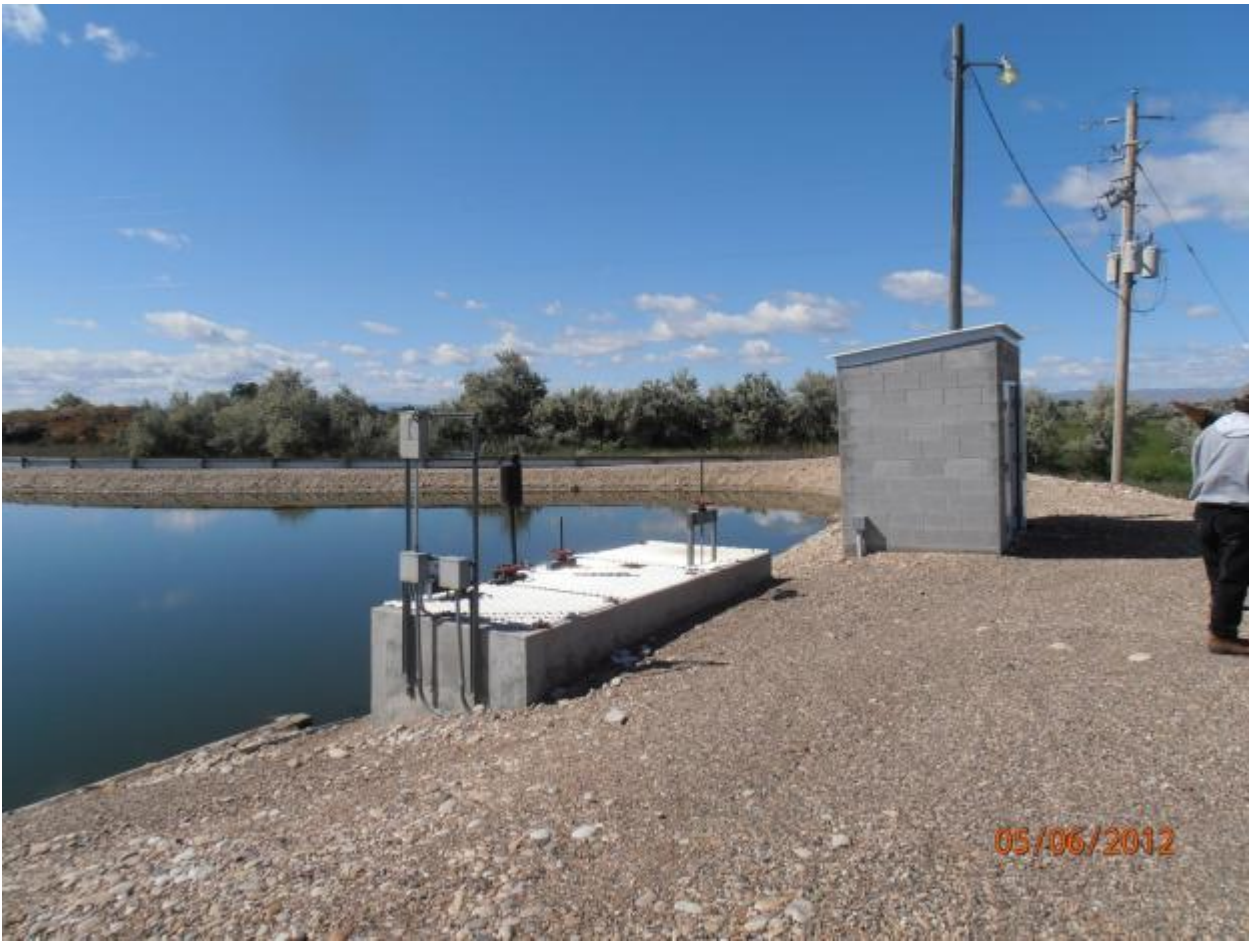
Photograph 18. Pump Control Building and lift station head works at terminal end of Lagoon #3.

Facing south. The head works can direct the flow from Lagoon #3 either to the next unit process, sand filters, or back to Lagoon #1.

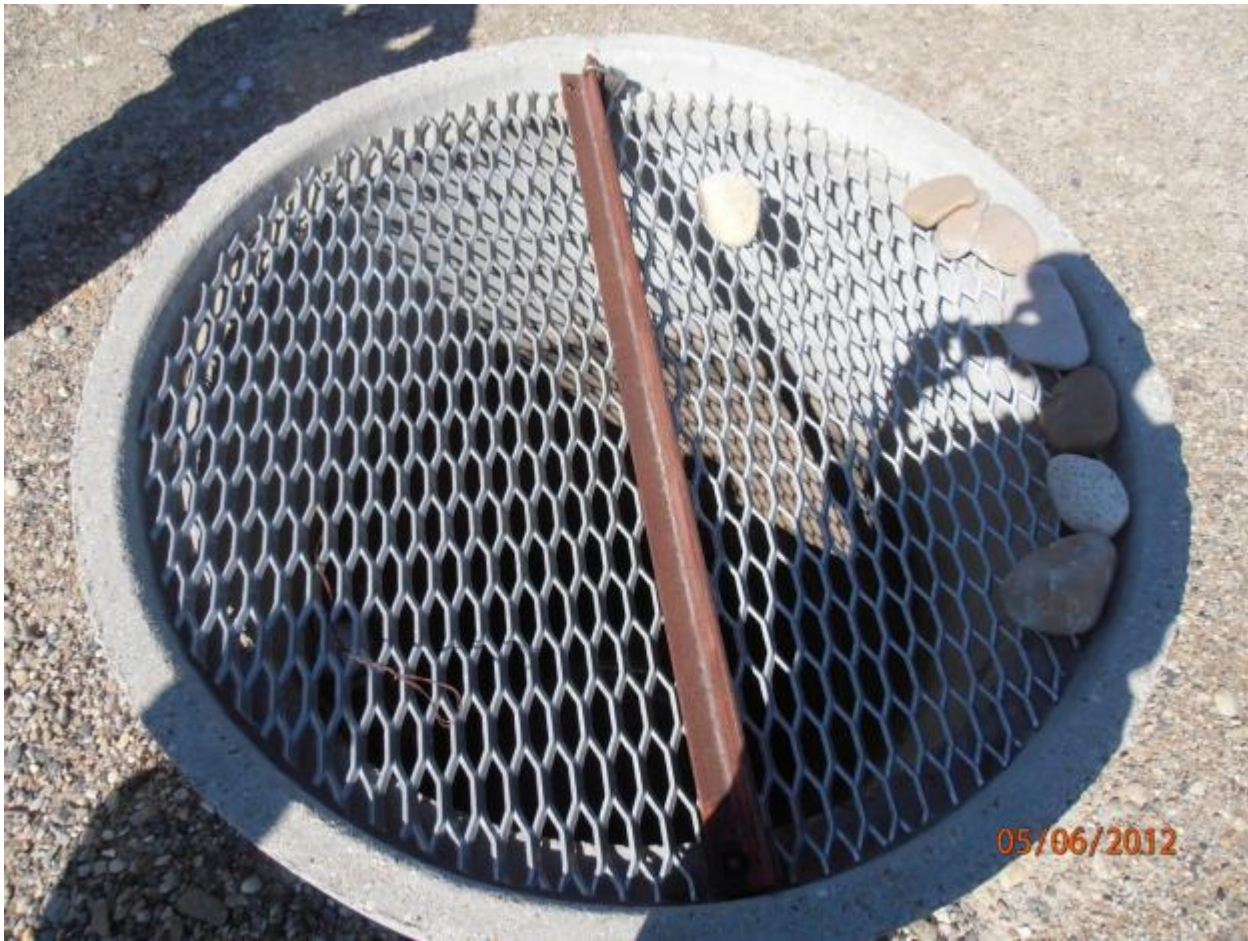
Photograph 19. Flow meter well.

Well is located about 25 feet north of the Motor Control Building and 15 feet west of Lagoon #3's discharge head works.

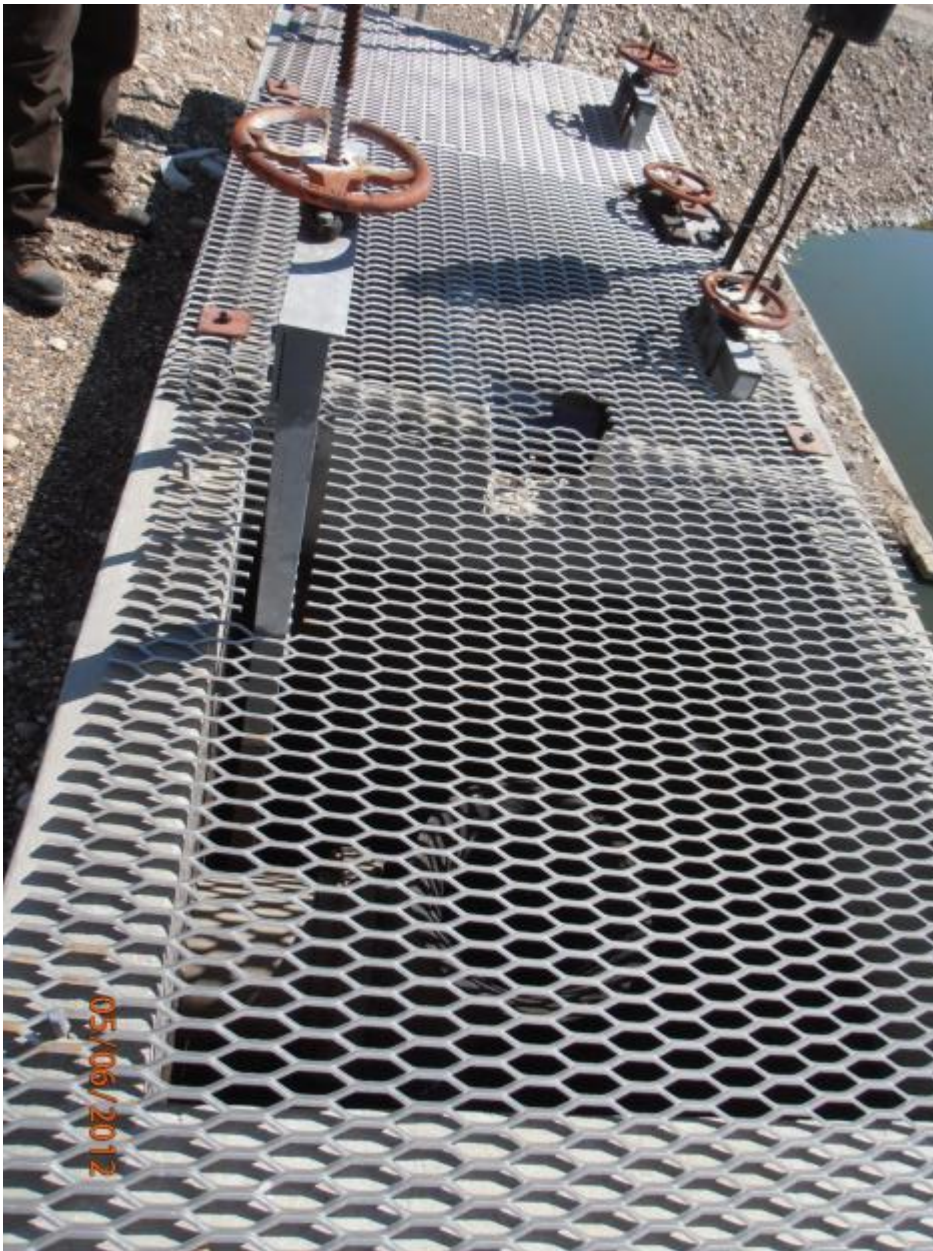
Photograph 20. Lift station from Lagoon #3 to sand filters, or return to Lagoon #1.

Facing northeast. Lagoon #3 on right. Lagoon #3 re-route to Lagoon #1 entrance visible below grating.
Lift station pumps to sand filter located in wet well at top of photo.

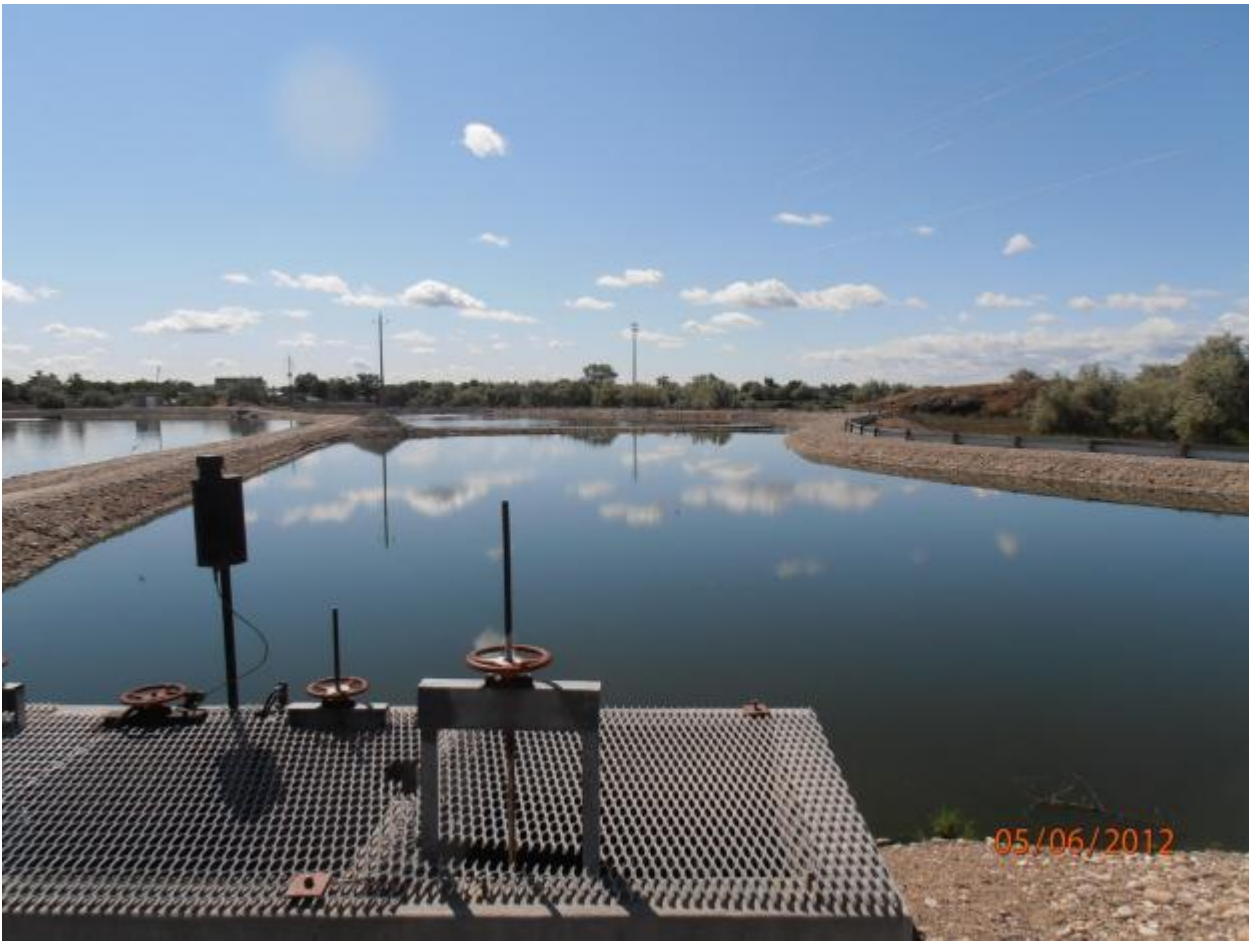
Photograph 21. Lagoon #3 in foreground, Lagoon #2 in background, and Lagoon #1 on the left.

Facing south southeast. Lagoon #3 in foreground, Lagoon #2 in background, Lagoon #1 on the left, and Sandhollow Creek flows on far side of metal panel fencing below the Russian olive trees.

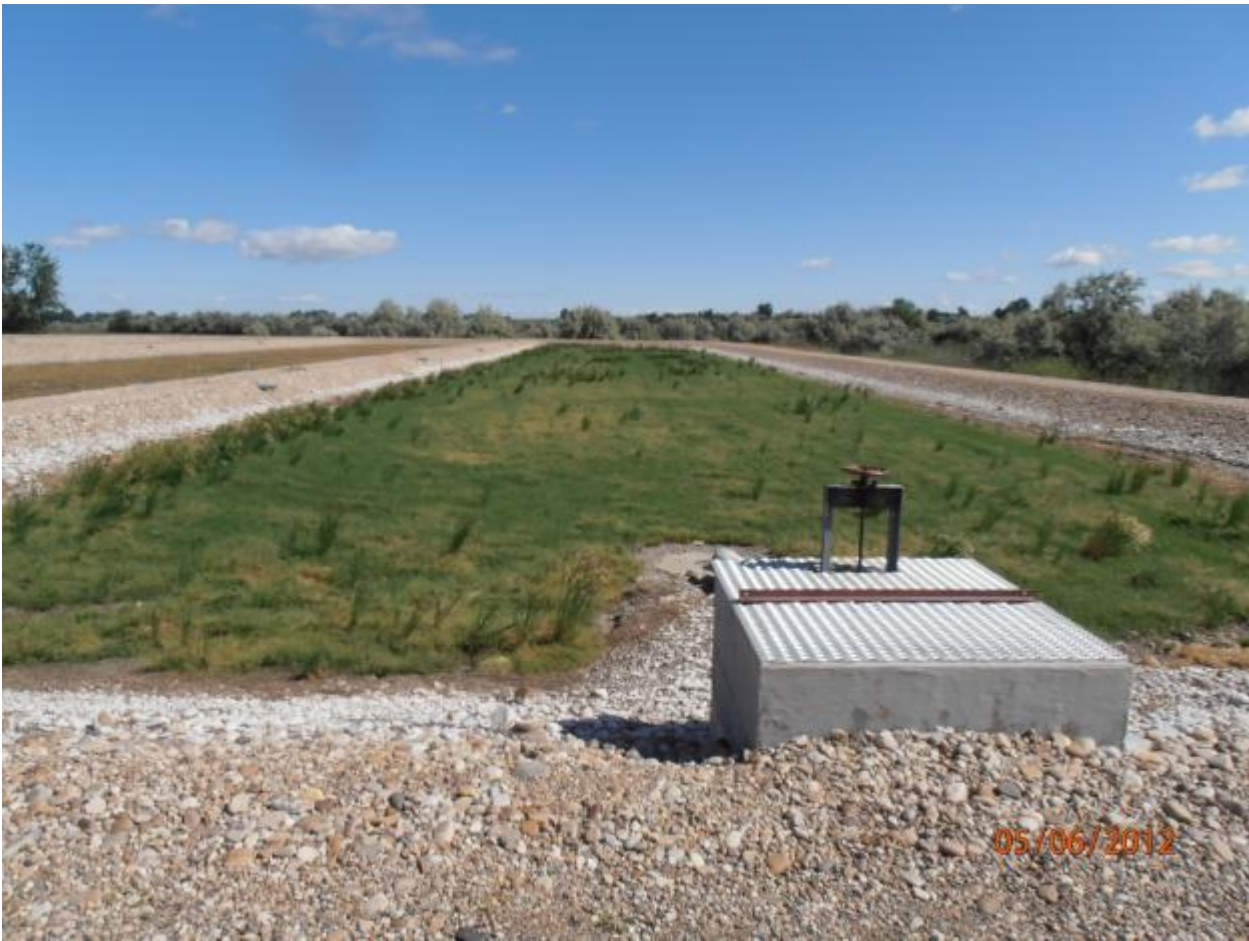
Photograph 22. Basin #1.

Facing north. Infiltration Basin #1 is the first basin encountered when traveling down the service road from Lagoon #3. Parma personnel refer to these infiltration basins as rapid infiltration basins, when a more appropriate descriptor would be an unlined sand filter. The basins do not have a liner, but they do have an Underdrain Collection System that routes filter effluent to the chlorination basin and final discharge point in Sandhollow Creek.
